TEST REPORT

Report No.: C4921.01-901-44

PRODUCT TYPE: Aluminum Cladding System

AAMA 508-07, *Voluntary Test Method and Specification for Pressure Equalized Rain Screen Wall Cladding Systems.*

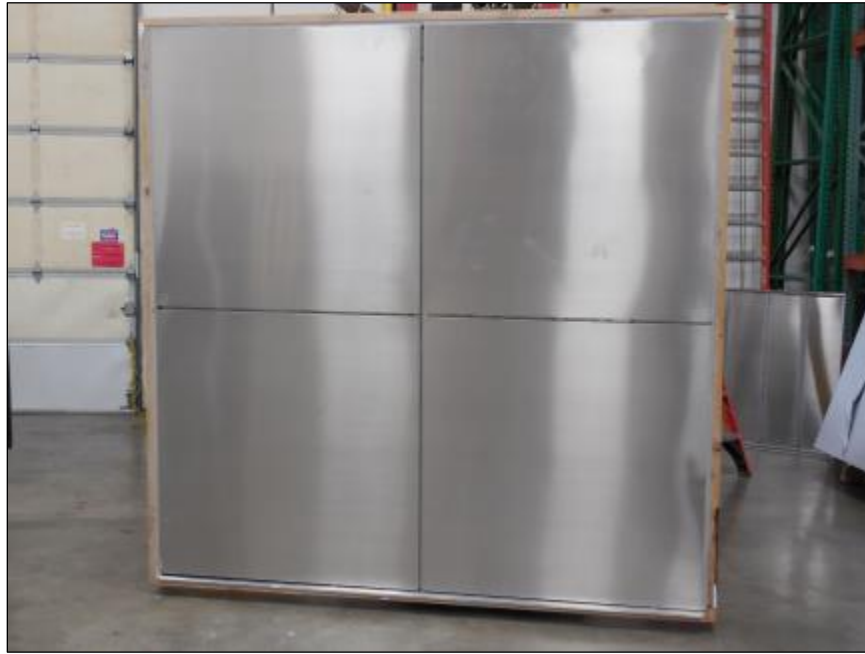
Exterior face of test specimen

5.3 Test Wall Construction: The 96" wide by 96" high test wall was constructed of 2 x 6 Douglas Fir wood studs. The studs were spaced 16" on center inside a 2 x 10 wood buck. The stud wall was covered with 1/8" thick clear polycarbonate and sealed and secured to the exterior of the wall to simulate an air/water barrier. The wall panel system was then installed onto the clear polycarbonate in a manner consistent with normal construction procedures for the system. The clear polycarbonate was calibrated to a pre-determined air leakage rate by drilling 1/8" diameter holes on the backside in a uniform pattern, making sure to create an even pressure drop and leakage rate across the wall and in each quadrant.

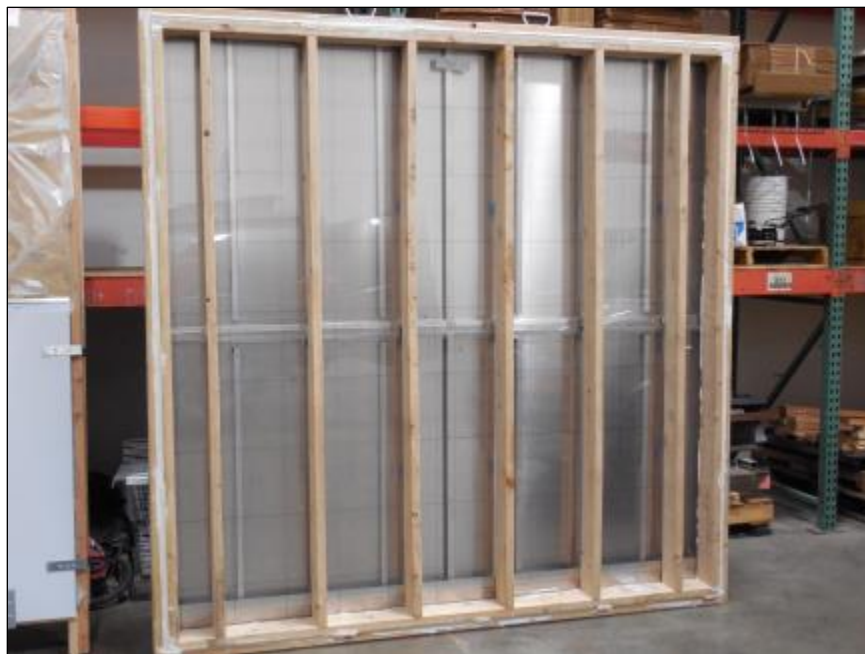
Interior face of test specimen
